Case 334 : Narrative

Case Vehicle (A): 2000 GMC
Type: Sierra 1500, 4 x 4, 2-door pickup
Driver: 21-year-old male
CDC: 12-FDEW-2, 00-TPZN-2

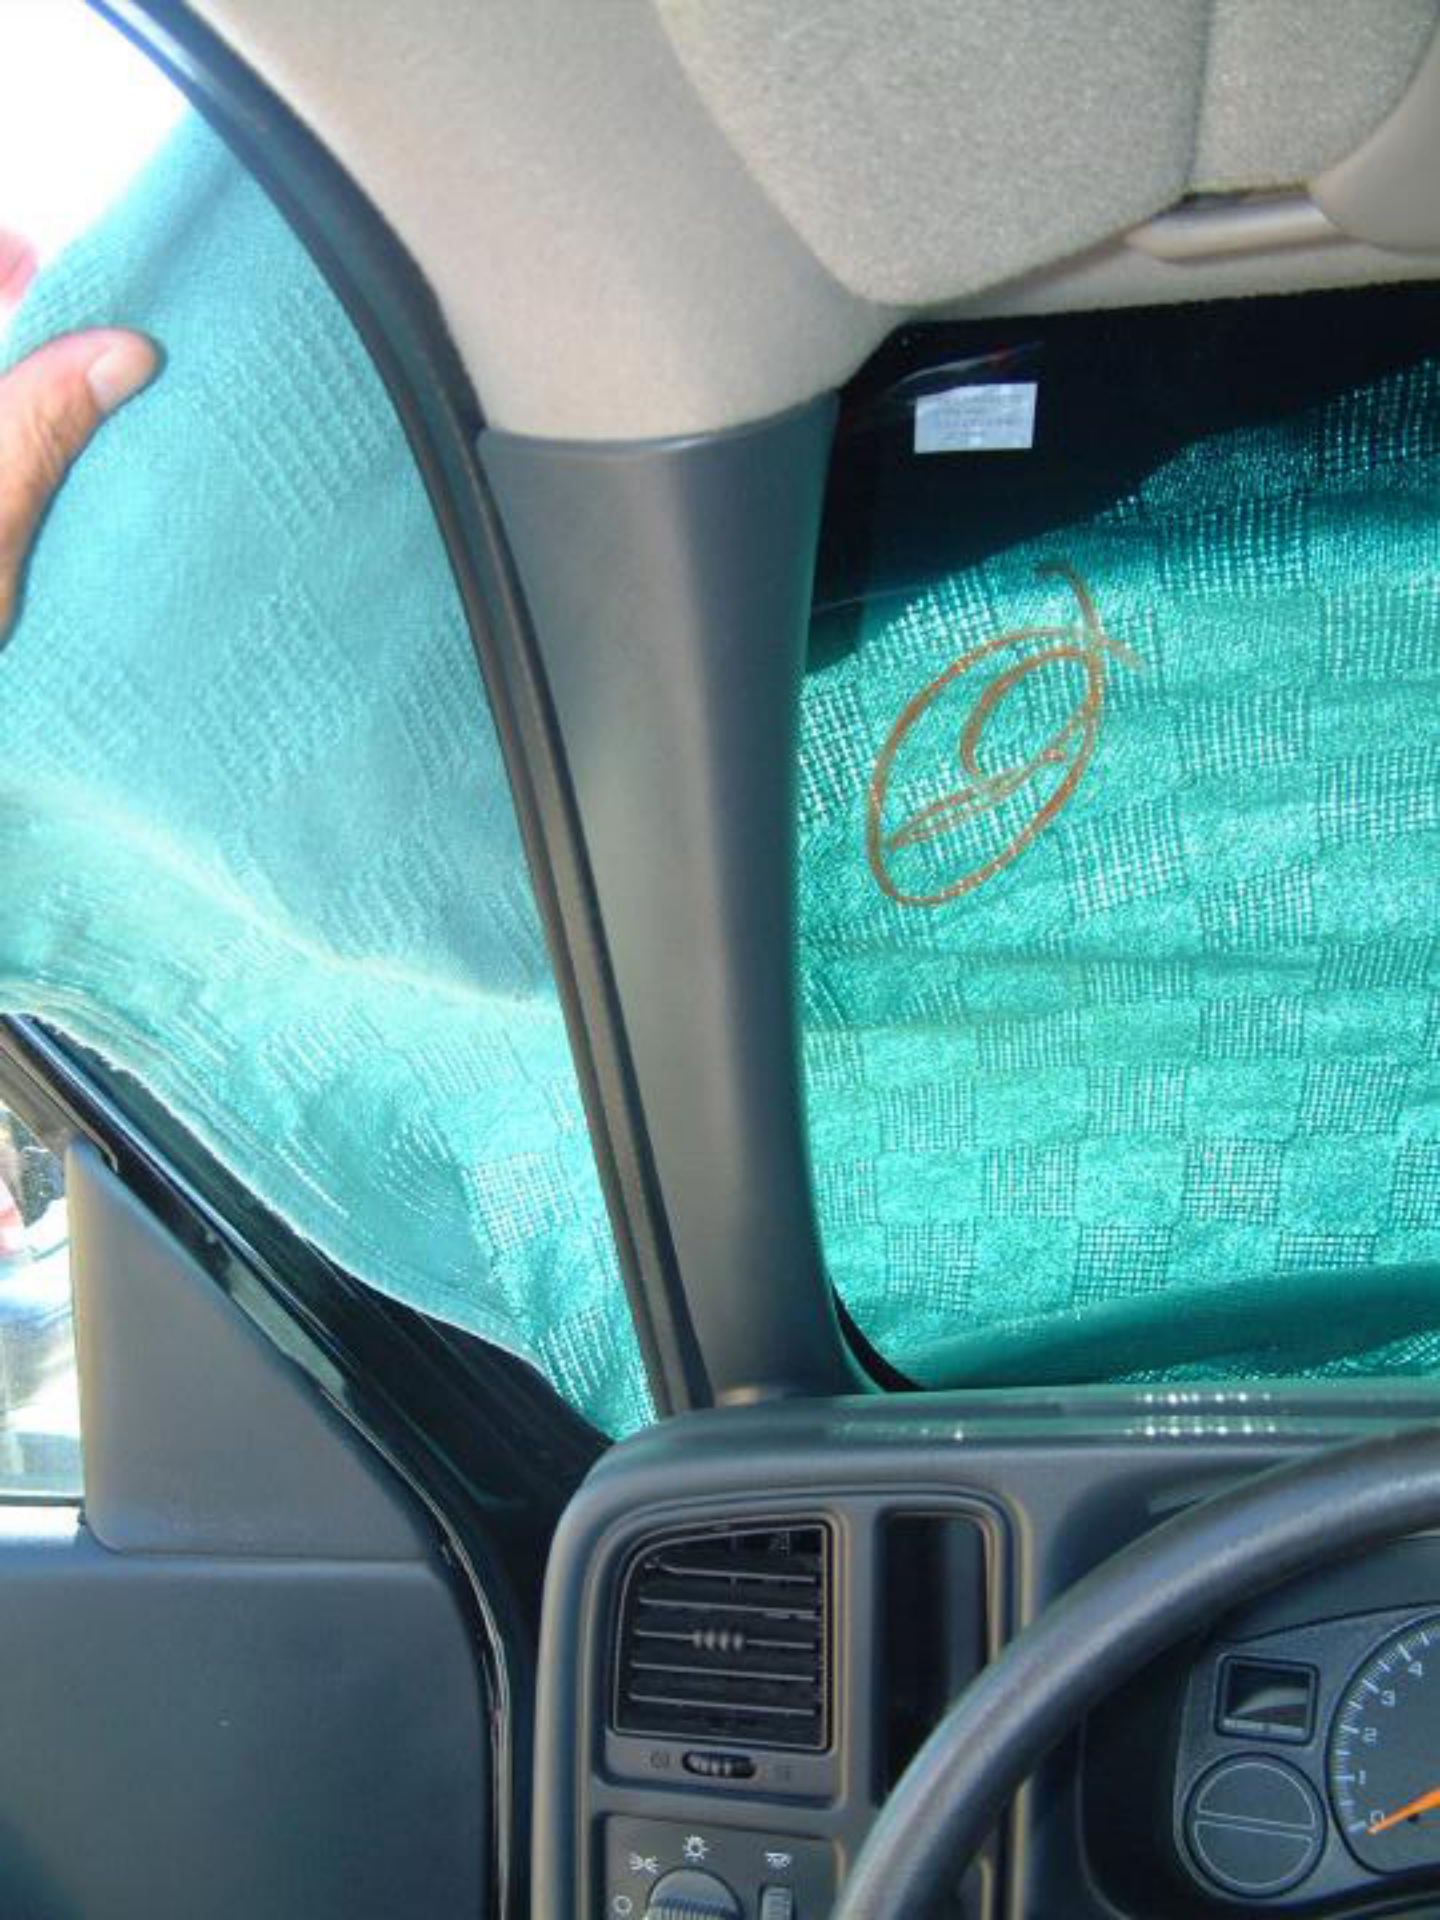
Prior to impact, the driver had fallen asleep. On impact, the driver moved forward into the three-point belt and airbag. He sustained a cervical strain, possibly due to impact forces.

The following table and attached drawing [56](#) summarize the injuries sustained by the driver of case vehicle (A).
